DO- the over of Rainbow

Emergency repairs restore damaged bridge ahead of schedule

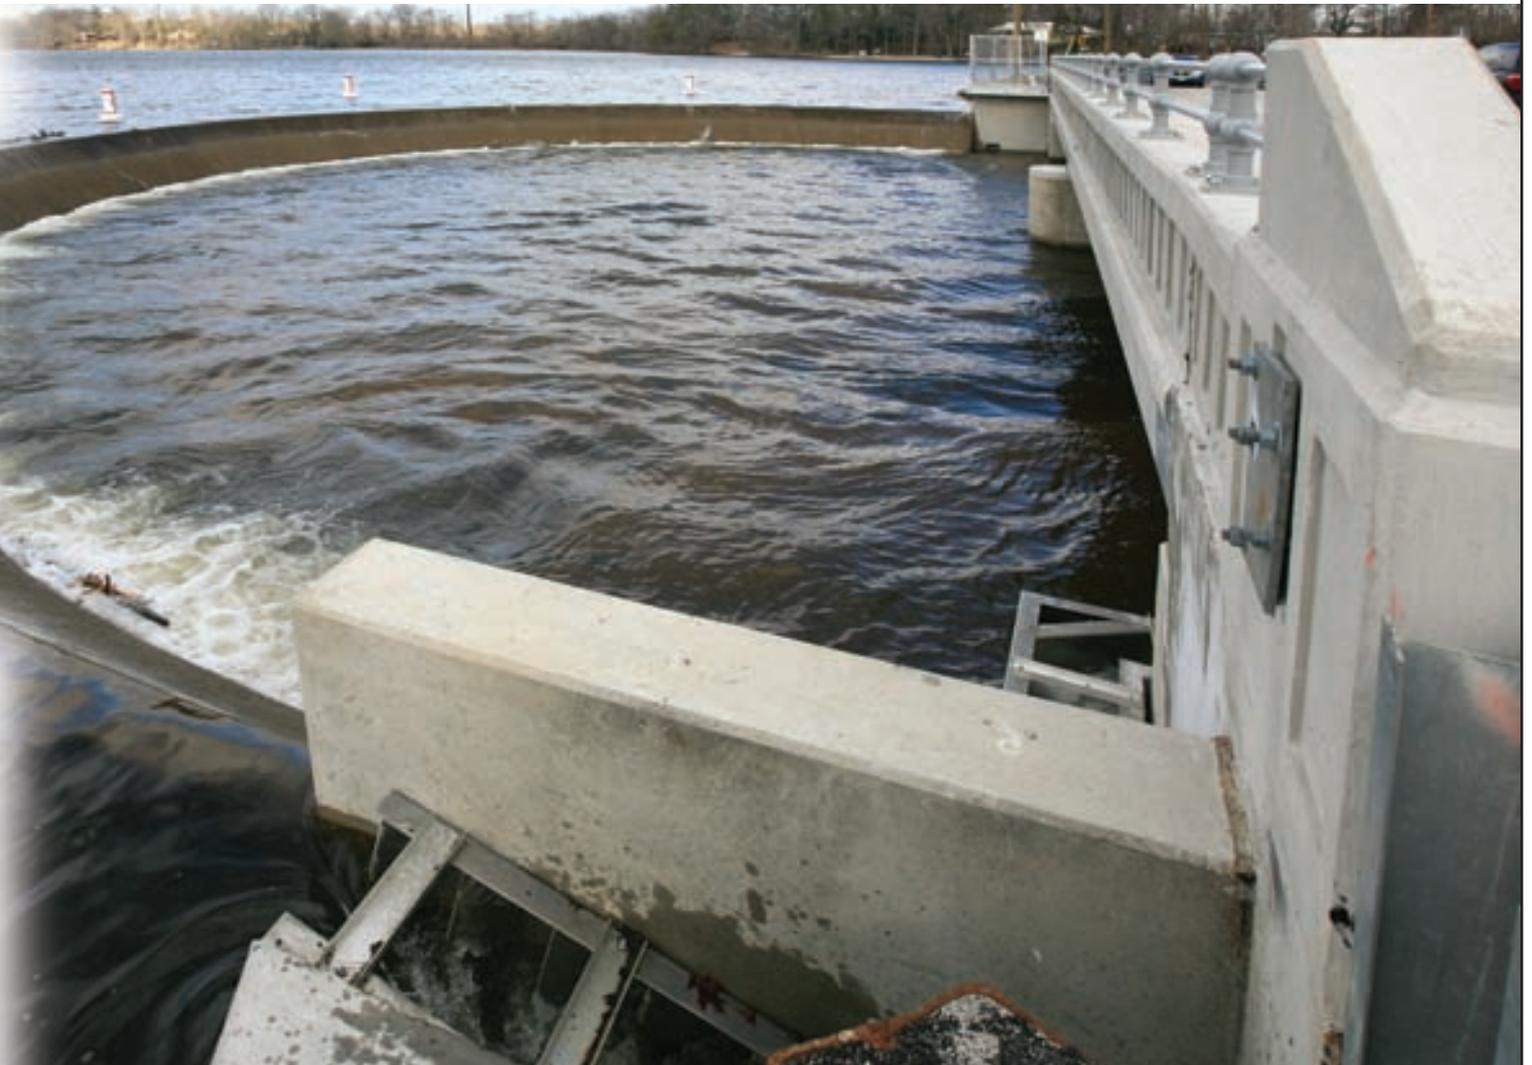
Left: The Rainbow Lake dam was breached, resulting in an 80-ft-long collapse of the entire roadway embankment. Above: The bridge was designed to accommodate a tangential alignment located on a curved roadway.
